Selected Paper of 6th World Conference on Design and Arts (WCDA 2017), 29 June – 01 July 2017, University of Zagreb, Zagreb – Croatia

Impact of the Cultural Changes After the Population Exchange on Spatial Organization and Use of Spaces: Case of Trilye Houses

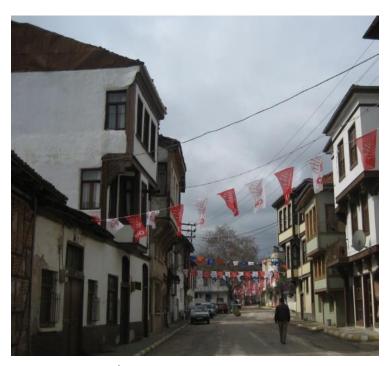
Figure 4. iskele Street, North-South view (P.A.)

Iskele Street takes the name of Karacabey Street from the middle of the town and reaches out to the southwest, and then links to its parallel Mudanya highway after taking a U turn. The street is the main axis of the town with 15 great plane trees and many public buildings like coffee houses, a wedding hall, the municipality, post office, city park located on it. It extends along to the port through the sea direction and to a fountain through the land; all the roads come down to the main road like a 'fishbone' or 'veins of a leaf', also the roads following the slope lines link to the fountain square from the both sides of the valley (Dostoglu, 2000) (Figures 2 and 4).

Considering the topographic structure of the land, wide squares or green areas were not planned within the street texture of Trilye. Since the houses are located adjacently, they could not have large gardens (Figures 2, 3 and 4). However, the collacation of buildings and greenery could be achieved by means of grapevines that overflow from the gardens and envelop the houses. The public necessity for green areas is satisfied (Figure 5).

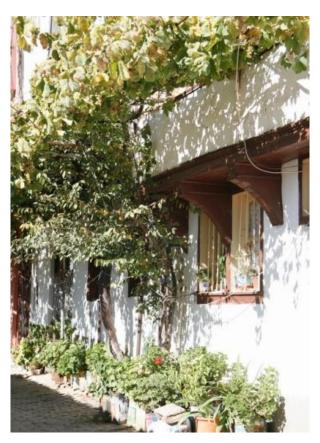
Figure 5. Building-green association (P.A)

In Trilye, since the parceling of street directions was not determined in terms of perpendicular placement, the gaps and quasi-square spaces occurred through the texture of organic convolutions serve as a device that strengthens the communication of people in the neighborhood. In some cases, this kind of spatial expanses especially located at the end of streets and enriched by some urban accessories like a plane tree or fountain are convenient for the returns from the narrow streets which were designed for transportation by animals as required for the traditional city life instead of motor vehicle traffic (Figure 6). Trilye streets act as gardens for the houses which lack actual gardens and sustains the 'urban outdoor living' tradition as spaces which are decorated with colorful flowers and used as socialising corners (Figure 5).

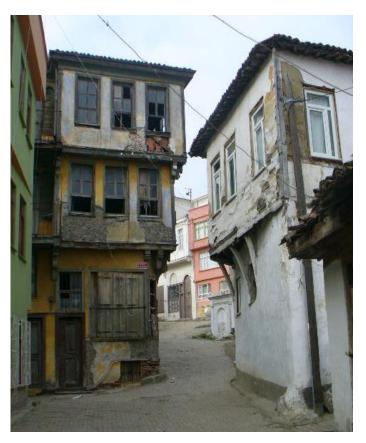
Figure 6. Two-three stories wood framed-masonry Trilye houses (P.A)

Situated compatibly with the street texture, the Greek-Turkish houses generally face outward and are as inviting buildings. Mostly having three stories, the houses are constructed with masonry and wooden framework. Wood sidings used in the facades and, surrounding the windows, make the plan and construction features of the houses explicit. The floors are raised by making cantilevers in most of the cases. The ground floor of the houses serves as stony ground (taslik), cooking oven, shed, store, olive granary and kitchenware. Households prefer to live on the ground floors since they are quite cool in summertime. Before 30-40 years, silkworms were being bred and the maintenance of cocoons was being held on the second floors. Also, the second floors were used for drying fruits. The major living spaces are the third floors with high ceilings. These floors are facing outward with many thin and long windows. Instead of protecting the personal privacy, the few and small-sized windows on the lower floors are assumed to be designed to protect the olive granary from the effects of outer factors (Figures 6 and 19). There is no separate space for a bath in the buildings, but there is a bathing area at the corner of a room which is called the gusulhane (bathing cubicle). Gardenless Trilye houses with adjacent system plans have double-leaf doors. The half round pediments turn these normal sized doors into more gorgeous sizes. The vitreous pediments ensure the lighting of the interior space. Embroidered woodworks are seen to be used in the drip moulds and interiors of houses, ceilings, frames of windows and doors and also ceilings covering bottom of cantilevers and wooden pillars bearing bay windows (Figures 6-14).

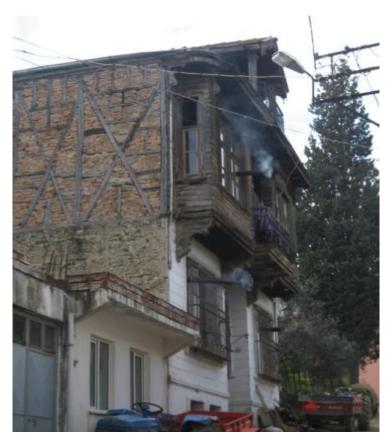
Figure 7. Cepneli Mehmet Bey House (P.A)

There are two rooms situated on both the sides of the entrance, a store and a space serving as a kitchen as well as a granary at the ground floor of this house which was bought by farmer Mehmet Bey during the years of the Independence War and was not renovated due to financial difficulties (Figure 7).

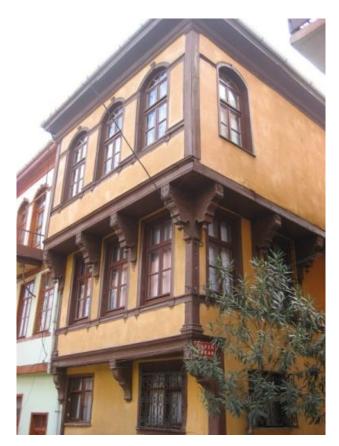
Figure 12. Huseyin Cebi house (P.A)

This construction, which is regularly renovated by its owner is one of the best protected examples in Trilye. Thus, it could be observed that while the house reflects the characteristics of Turkish architecture with the size of its windows, cantilevers, wardrobes and shelf arrangements within the rooms, it also reflects the features of Greek architecture with ornaments on the windows pediments, pillars and lower ceiling cantilevers. Conserved ceiling ornaments and balustrades exhibit the handicrafts of the period. The details above the doors (Figure 13) do not possess the features of Turkish houses, in a similar manner, the height of the shelf were arranged unlike the Turkish style. The shelf called 'sergen' located in reference to underneath of windows.

Considering the needs of nowadays, it can be said that the adjustments are suitable. For instance, the entrance from the front facade of the building that has two facades through the store and granary is closed and the entrance relocated to the side frontage, since this area turned into a living space (Figure 12). As the bathroom started to be implemented as a distinct space in daily life, gusulhane were transformed into pathways which reaches to the roof (Figure 14).

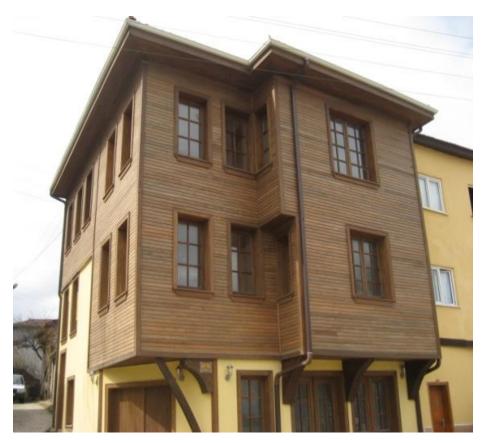
Figure 16. Renovated house on the beach (P.A)

As seen from the post renovation photographs of the building that are acquired from the municipality, the former state of the building was completely changed since it was renovated and turned into a hotel by its latest owners. While the building seems to preserve room-hall feature on its plan, it was designed as a small hotel with room-bathroom mould. Either room design or material usage is rather far away of being authentic. Its ceilings were built according to original design but with different materials.

Spaces like bathroom-restroom were added and simply artificial settings were created by using unfamiliar materials like ceramics and wet floor components like toilet bowl, lavatory and shower. It became an unsuccessful sample of restoration wandered away from the features of Turkish houses (Figures 16–18).

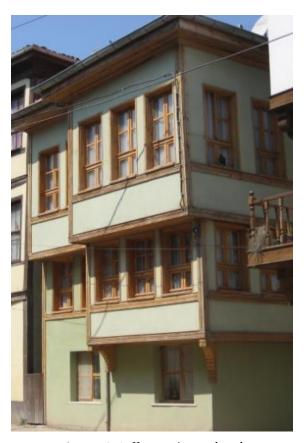
Figure 19. Saffet Bey house (P.A.)

This is a typical Trilye house with its few windows on the ground floor and cantilevered upper floors (Figure 19). However, the building underwent quite comprehensive renovation that the authentic form completely changed with regard to construction techniques and used materials. (Figure 21). The ground floor consisted of two rooms and a hall is considerably evolved, since one of the rooms transformed into a kitchen equipped with latest technology (Figure 20) and the hall is minimised by adding a restroom beneath the stairs (Figure 21). Wall panels were installed, grounds and stairs were covered by polished woods. This spatial configuration resembles the current summer suits in Turkey (Figures 20 and 21). In the middle floor, the original two rooms-hall-iwan plan is conserved and in one of the rooms sitting layout of the Turkish home is organised with the sofas set all along the windows. Nevertheless, windows, ceilings and materials are not authentic (Figure 20). The top floor which was previously a living space, serves merely as a sleeping area. The iwan in this floor was closed by incorporating to one of the rooms. Thus, the iwan disappeared and the light flowed from the iwan was blocked.
